DYacht Inadee – MDTF7

PROCEDURE

Westerley Fulmar Windows

Toughened Glass Replacement

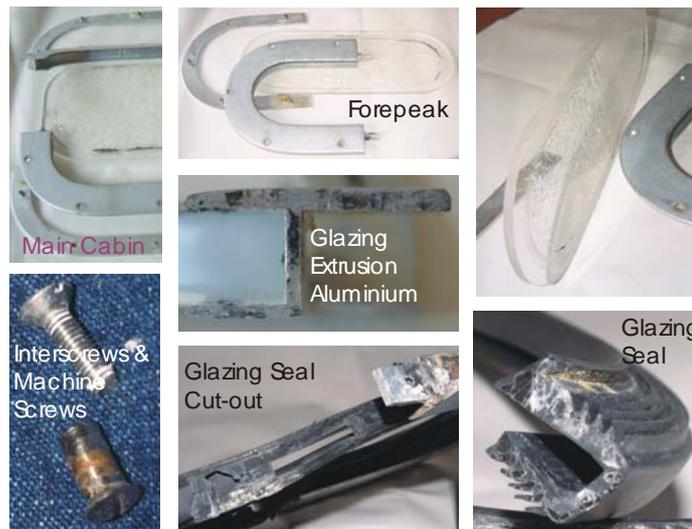
Figure 2: General View of Window Components

The rubber seal has a cut out adjacent to the junction of the frame halves to accommodate the securing plate and screws. See *Figure 2: General View of Window Components*. After the delicate and show of strength to remove the frames from the panes you are ready to prepare the frames for the first stage of re-anodising and measure the panes so that the new toughened glass can be ordered. It is also a good idea to clean all the crud off the rubber seal; I managed to use mine again for it will last at least another ten years or so.

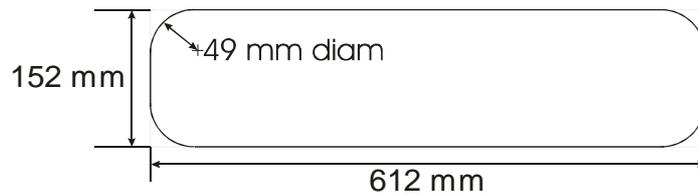
Figure 3: Main Cabin Window Specification

Clear Toughened Glass 5 mm thick

4 Pieces

Main Cabin

Toughening Specification: BS857

Piper Glass at Watford and Crouch Marine in Essex. I chose the more expensive option, Crouch Marine, because the guy had been very helpful. See *Figure 3: Main Cabin Window Specification* and *Figure 4: Forward Windows, Heads, Lockers & Forepeak Specification* for the dimensions of my windows.

When sizing the glass be aware that it is best to be slightly undersized than oversized because of the clearance between the frame securing screws. There is a slight chance that they could come into contact with the glass when the frames are re-assembled.

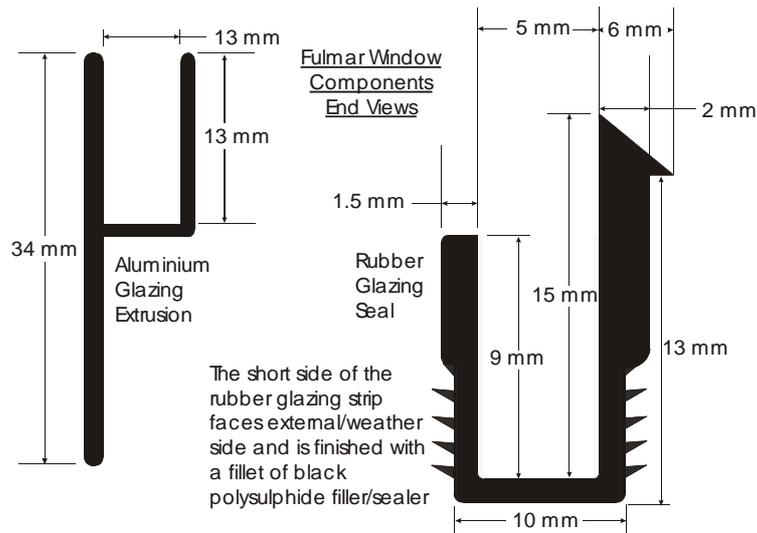
Figure 5: Glazing Frame & Rubber Extrusion Cross Section

Figure 5: Glazing Frame & Rubber Extrusion Cross Section, gives details of the dimensions of the aluminium frame and cross section of the rubber extrusion. Note that the higher part of the extrusion is on the inside of the frame and that after assembly it is necessary to squeeze a bead of UV resistant sealant on top of the extrusion, between the pane and the frame, on the outside.

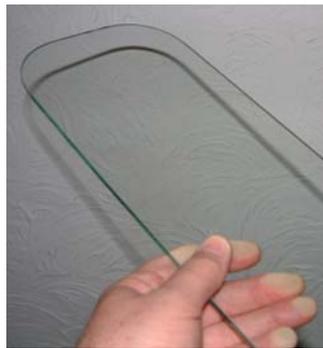
Figure 6: Toughened Glass Window Pane

Figure 6 shows the toughened glass prior to assembly. The glass must be cut to shape before the toughening process and is impossible to cut after toughening.

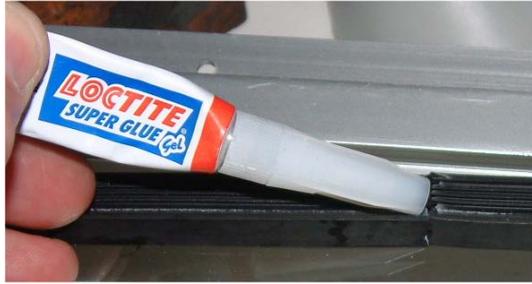
Figure 7: Bonding Rubber Seal

To avoid creating a gap between the ends of the extrusion when re-inserting the pane and extrusion into the frame I used a little Superglue on the extrusion after assembling the extrusion around the glass. No Superglue should come into contact between the glass and the extrusion.

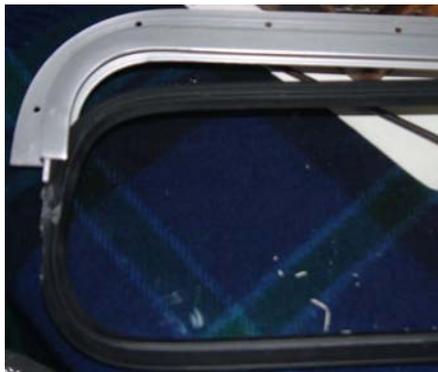
Figure 8: Inserting Glass & Rubber Seal into Frame

Assembly of the glass and extrusion into the frame is relatively straight forward as long as the thickness of the glass is only 5mm. I experienced one or two glass suppliers who tried to convince me that 6mm glass could be used but this is not so. If it is absolutely necessary to use any form of lubricant to get the frame and glass assembled then only lubricate the inside wall of the frame. Lubricating the outside of the frame could affect the bead of sealant from making a good seal. Just before the pane seats fully into the frame I advise using a little sealant around the extrusion adjacent to the frame joint. This will reduce the risk of water ingress. See *Figure 8*

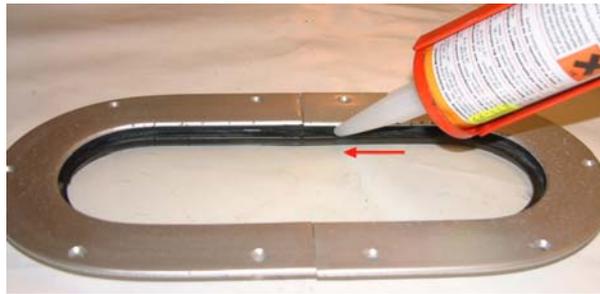
Figure 9: External Sealant Bead (Sikaflex)

Once the pane, extrusion and frame have been assembled and the seal inspected for correct seating in the frame the bead of UV resistant sealant is applied. Make sure that the seal is about 3mm below the edge of the frame so that the sealant has good contact with the frame. I found that I could just push the extrusion into the frame with the handle of an old spoon. Finally, I cleaned the glass and area where the fillet was to be inserted with methylated spirit. When applying the sealant it is good practice to trim the application nozzle to about 6 mm diameter and at an angle of about 45 degrees and to 'push' the sealant gun into the gap, not 'pull' it. See *Figure 9*.

Figure 9 also gives a good indication of the effect of re-anodisation. Although it does not get rid of pitting corrosion the anodising effectively anodises inside the pitting and screw countersinks.

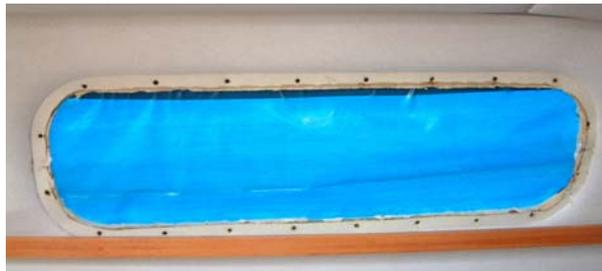
Figure 10: Main Cabin Window: Cut-out, Inside view

Figure 10 and Figure 11 show the inside and outside of one of the prepared cut-outs.

Prior to fitting the frames into the boat it is advisable to remove all debris from around the cut-out and to clean the internal surface of the headlining which is trapped beneath the frame plates. Best to give the external surface a good clean too so that the sealing putty can make good contact.

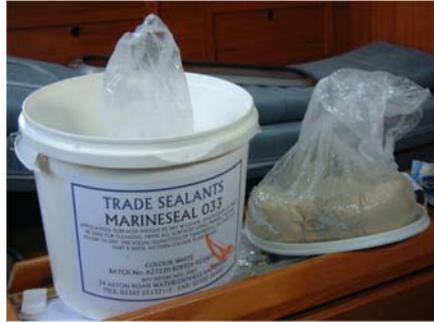
Figure 12: Window 2 Part Putty Sealant

The next job is to kneed the two part putty. I used Marineseal 033 from Trade Sealants of Waterlooville, Hants. The putty cures like rubber with the feel and texture of an 'india' pencil rubber. The sealant is excellent for the interface sealing of keels when used with a primer, however, without a primer it is ideal for windows. At least you will be able to successfully and, relatively easily, remove the window at some time in the future.

To estimate just how much putty is required I found that a 'sausage' no more than 10mm in diameter squeezed around the outside edge of the cut-out is sufficient to be forced to the inside of the frame and to be squeezed out from the edge of the frame. The working life of the putty is more than a day so any surplus putty that is squeezed out can be re-used. I mixed about enough putty to complete two main cabin windows as it is quite a tiring job kneeding the two parts to an even consistency. Once mixed, roll the putty into a sausage and press it firmly to the edge of the cut-out. Figure 12 shows the pot of putty with one part in the plastic bag, like cheese, and the other, of similar texture in the tub. I wore vinyl gloves to kneed and handle the putty.

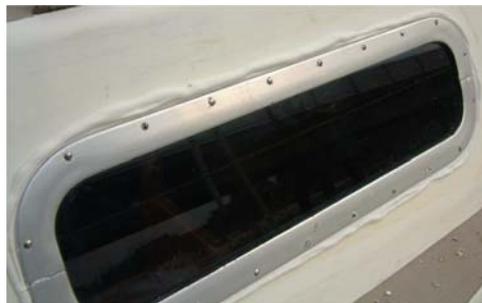
Figure 13: Main Cabin Window Inserted

Next job is to insert the Interscrews and secure the window in place. I recommend that the screws are placed diagonally and tightened down evenly around the window frame. I use an electric screw driver for the job ably assisted from the inside by 'The Boss'. *Figure 13* shows the putty squeezed out from the frame.

Offer up the frame to the cut-out and press firmly and evenly to force the putty into the inside of the boat and from the edge of the frame. I used my feet to press the window into place, being careful not to apply pressure unevenly. It is also important to leave about 2mm thickness of sealant between the interface of the frame and coach roof so the when the seal cures the window can be nipped up.

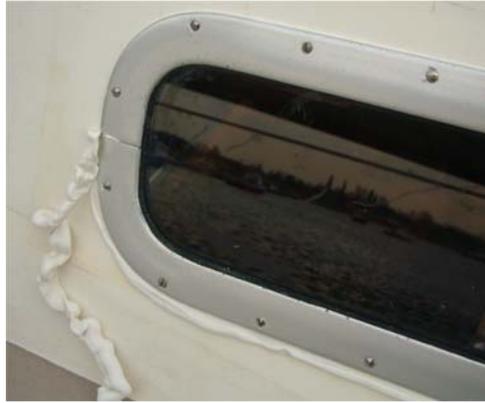
Figure 14: Trimming Surplus Window Sealant

Last but not least, remove the surplus putty from the surrounding frame with some suitable spatula; I used the clean but blunt 25mm wood chisel.
